6 George Whittell High School

6.1 Description

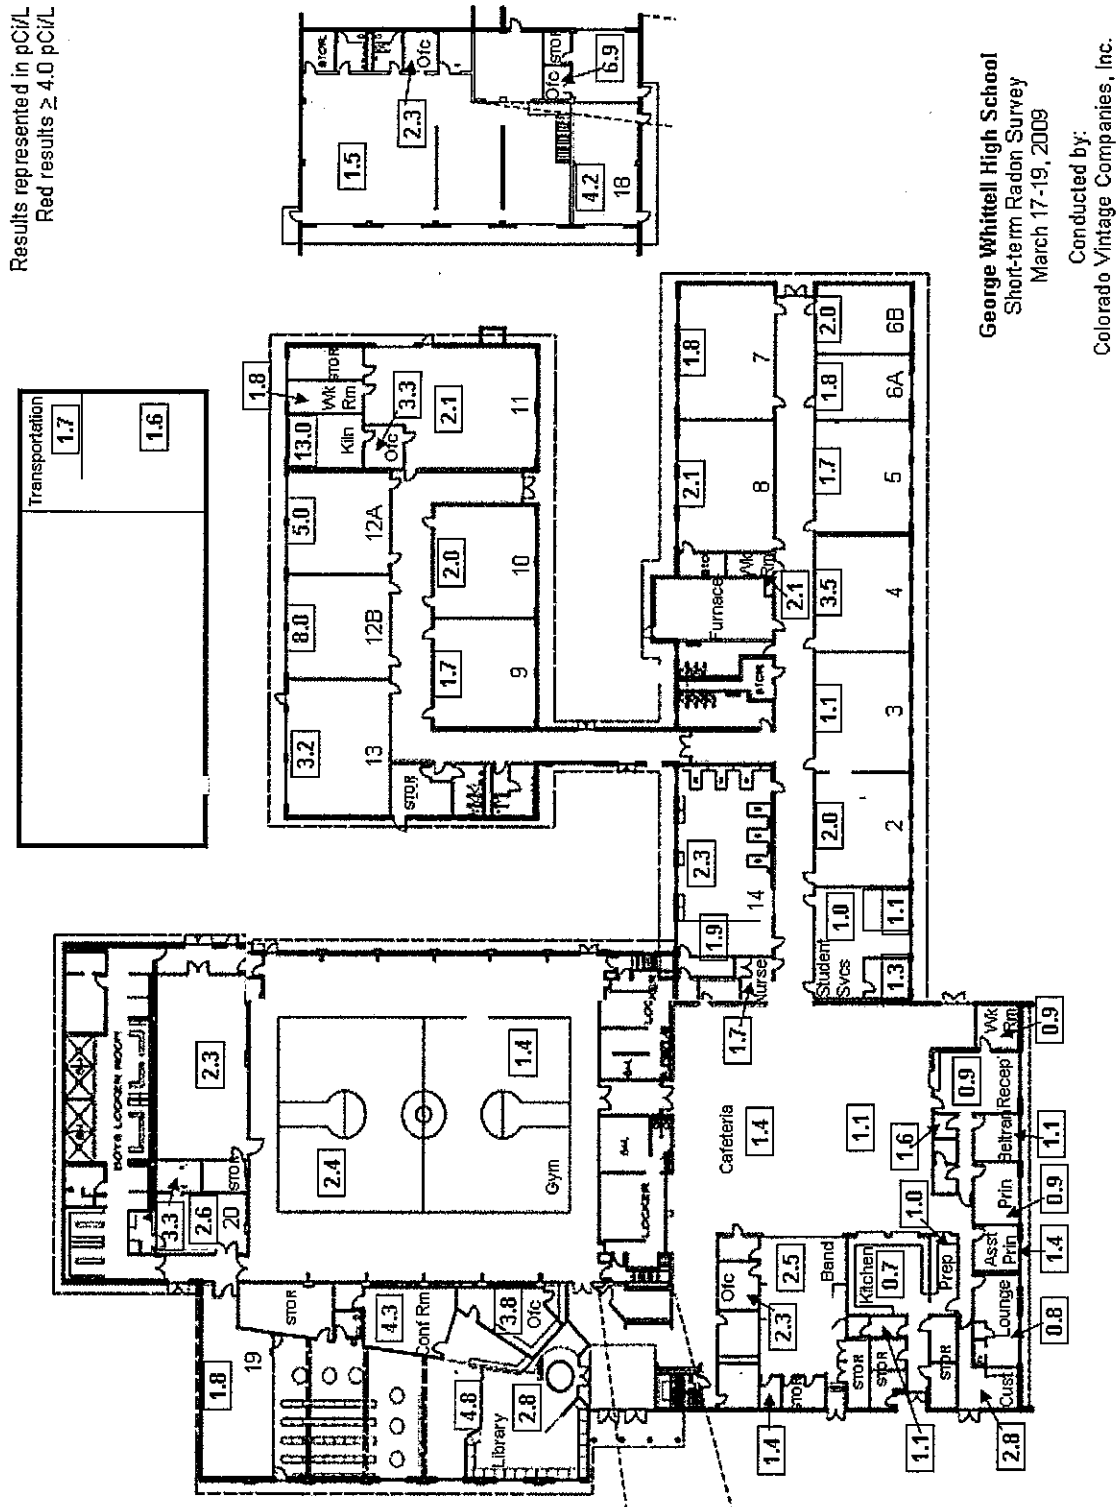
Figure 6: George Whittell High School Radon Survey Results

The results provided below in both tabular and pictorial form represent the radon levels within these locations that were present at the time of the survey and under the condition in which the building was being operated, including its HVAC system. Locations determined to have short-term radon levels at or above 4.0 pCi/L are shown in "bold" within the table and in red on the diagram.

It is apparent that the potential exists at this school for elevated radon. This is not totally surprising due to the granite geology at this school and its proximity to Zephyr Cove Elementary where previous testing had led to the installation of active soil depressurization systems.

In particular, the Kiln Room had a short-term reading of 13.0 pCi/L. It is highly likely that, assuming the Kiln was in use during the test period, that either the natural venting of the Kiln or the presence of mechanical exhaust systems to withdraw exhaust gases from the Kiln are causing significant negative pressures in this room that would cause radon to enter through the foundation. This effect is also likely the cause for elevated measurements in the adjacent Rooms 12A and 12B.

The measurements for Rooms 12A, 12B and the Kiln Room can also be compared to much lower measurements on the opposite side of the hallway. This dichotomy of results is likely due to separate air handlers serving opposite sides of the hallway, or an imbalance in the supply ductwork, if there is a common FAU for this portion of the building.

The same imbalancing of air supply is also the likely cause for elevated measurements in the Library and its nearby Conference Room as well the Drama area in the old transportation building.

- Confirm elevated radon levels within elevated rooms with the use of a continuous radon monitor that, in addition to providing a confirmatory integrated measurement, it would also provide a more informative indication of the daytime to nighttime averages of radon exposure.

- Review HVAC system for elevated locations with a special attention given to the operation of exhaust systems that may be present in the Kiln area.
 - Insure both the presence and capacity of air supply to these rooms

- Adjust supply to maintain a 0.010 inch of water column positive pressurization within these rooms relative to the sub-grade.
 - Verify that positive pressure is maintained in all other rooms that are served by the air handler that serves the rooms that are elevated. If not, increase capacity of the air handler to insure positive pressure through adjustments to fresh air make-up and/or fan speed.

- After adequate HVAC adjustments have been accomplished, conduct short-term confirmatory measurements in all rooms served by the HVAC system that serves the rooms that are elevated.
